# 5940 SOQUEL AVENUE

## UNINCORPORATED SANTA CRUZ COUNTY

APN: 029-021-047  
**VESTING TENTATIVE MAP FOR CONDOMINIUM PURPOSES**  
TM-1

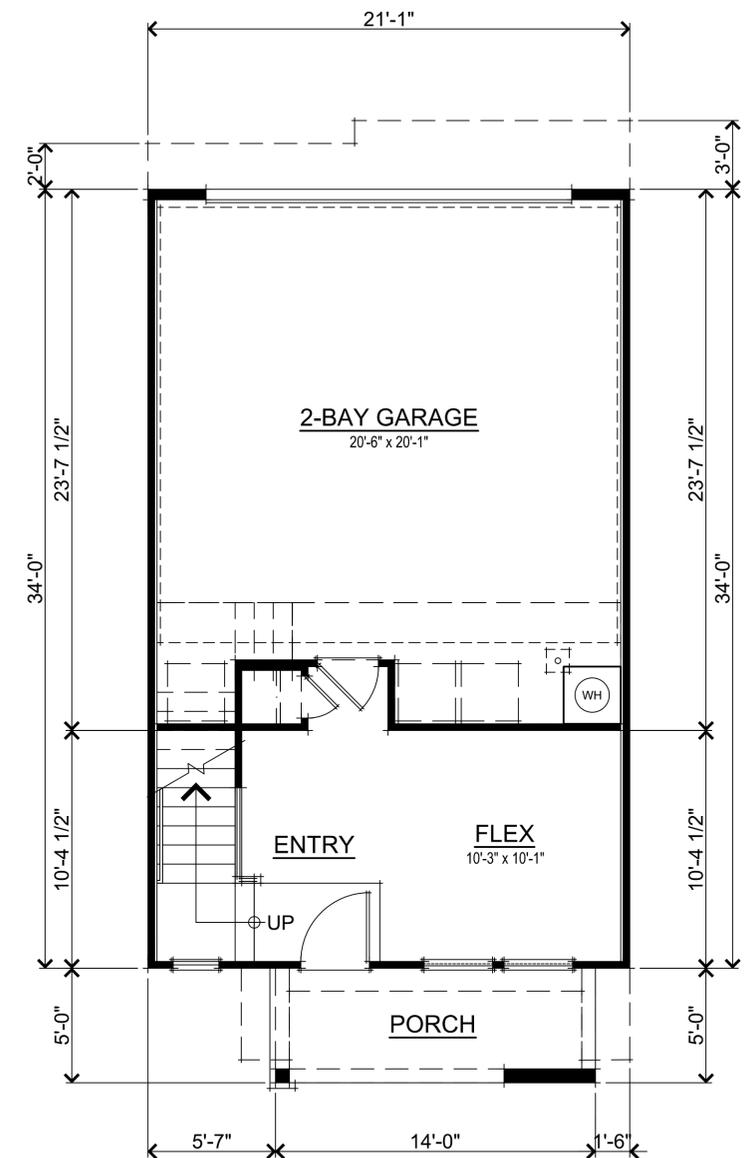
FIRST FLOOR PLAN

SQUARE FOOTAGES	
FIRST FLOOR	244 SQ. FT.
SECOND FLOOR	788 SQ. FT.
THIRD FLOOR	791 SQ. FT.
TOTAL LIVING	1823 SQ. FT.
2-BAY GARAGE	472 SQ. FT.
PORCH	72 SQ. FT.
DECK	52 SQ. FT.

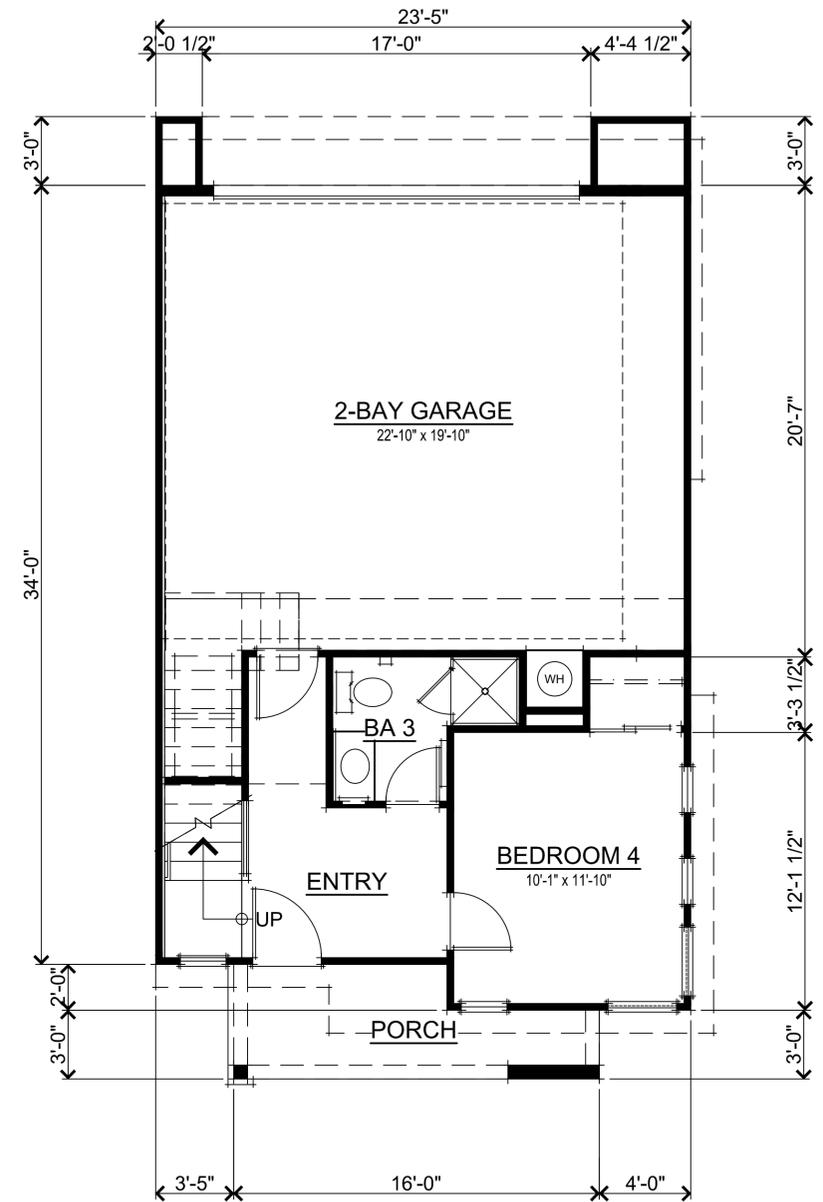
FIRST FLOOR PLAN

SQUARE FOOTAGES	
FIRST FLOOR	315 SQ. FT.
SECOND FLOOR	913 SQ. FT.
THIRD FLOOR	844 SQ. FT.
TOTAL LIVING	2072 SQ. FT.
2-BAY GARAGE	496 SQ. FT.
PORCH	68 SQ. FT.
DECK	40 SQ. FT.

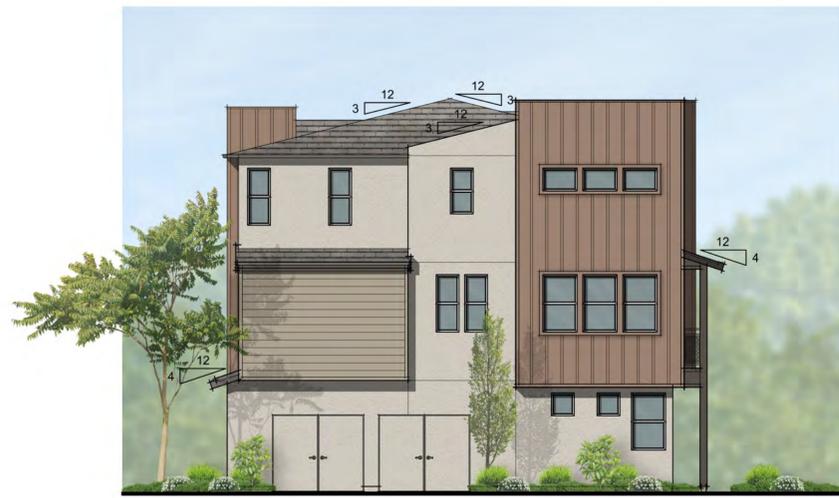
LEFT ELEVATION

- TYPICAL EXTERIOR MATERIALS
- ① - EXTERIOR PLASTER, MEDIUM SAND FINISH
  - ② - BOARD & BATTEN VERTICAL SIDING
  - ③ - FIBER CEMENT HORIZONTAL SIDING
  - ④ - PERFORATED MESH METAL RAILINGS
  - ⑤ - WOOD WINDOW TRIM @ SIDING
  - ⑥ - ARCHITECTURAL QUALITY COMPOSITION SHINGLE ROOFING

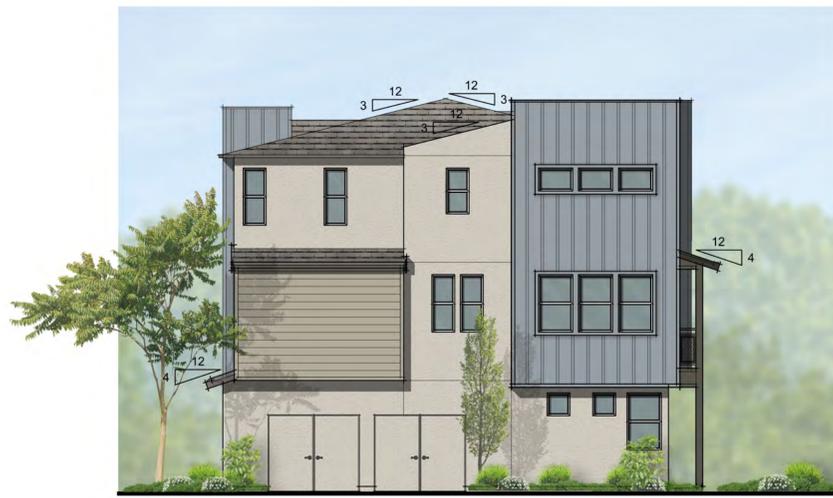
LEFT ELEVATION

- TYPICAL EXTERIOR MATERIALS
- ① - EXTERIOR PLASTER, MEDIUM SAND FINISH
  - ② - BOARD & BATTEN VERTICAL SIDING
  - ③ - FIBER CEMENT HORIZONTAL SIDING
  - ④ - PERFORATED MESH METAL RAILINGS
  - ⑤ - WOOD WINDOW TRIM @ SIDING
  - ⑥ - ARCHITECTURAL QUALITY COMPOSITION SHINGLE ROOFING

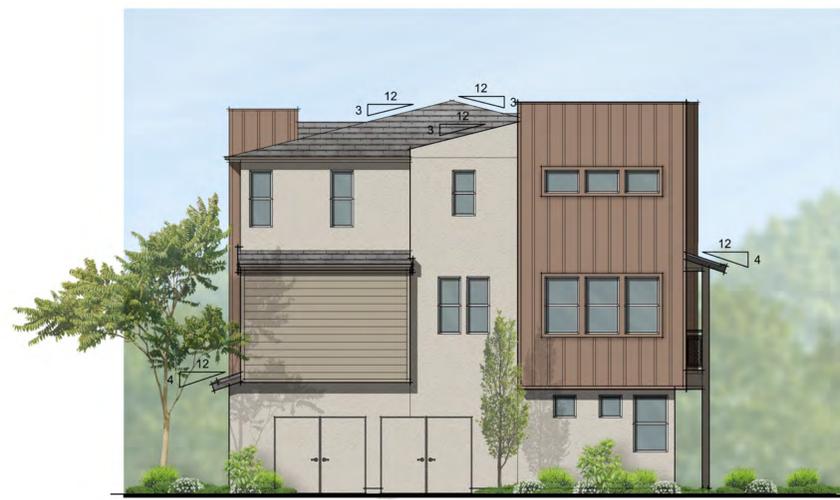
LEFT ELEVATION

- TYPICAL EXTERIOR MATERIALS
- ① - EXTERIOR PLASTER, MEDIUM SAND FINISH
  - ② - BOARD & BATTEN VERTICAL SIDING
  - ③ - FIBER CEMENT HORIZONTAL SIDING
  - ④ - PERFORATED MESH METAL RAILINGS
  - ⑤ - WOOD WINDOW TRIM @ SIDING
  - ⑥ - ARCHITECTURAL QUALITY COMPOSITION SHINGLE ROOFING

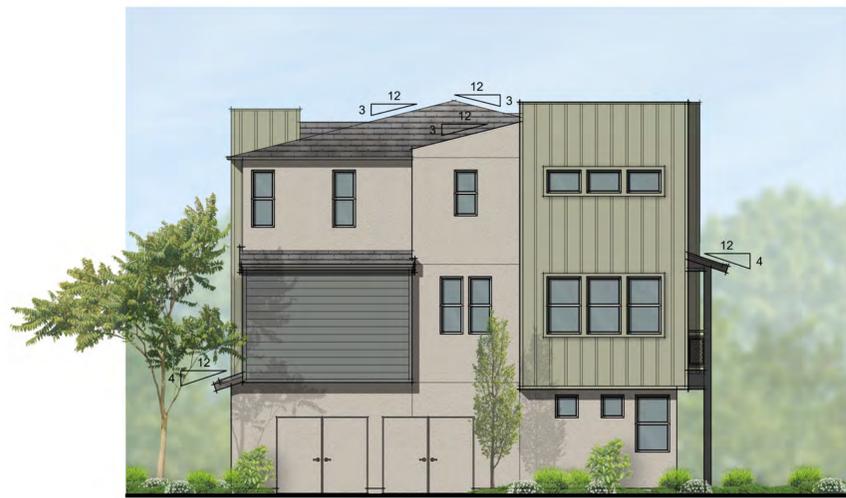
LEFT ELEVATION

- TYPICAL EXTERIOR MATERIALS**
- ① - EXTERIOR PLASTER, MEDIUM SAND FINISH
  - ② - BOARD & BATTEN VERTICAL SIDING
  - ③ - FIBER CEMENT HORIZONTAL SIDING
  - ④ - PERFORATED MESH METAL RAILINGS
  - ⑤ - WOOD WINDOW TRIM @ SIDING
  - ⑥ - ARCHITECTURAL QUALITY COMPOSITION SHINGLE ROOFING

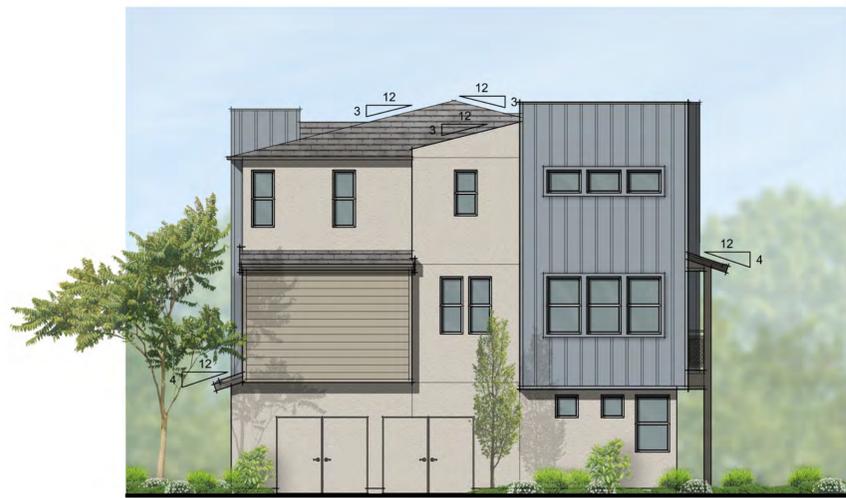
LEFT ELEVATION

- TYPICAL EXTERIOR MATERIALS
- ① - EXTERIOR PLASTER, MEDIUM SAND FINISH
  - ② - BOARD & BATTEN VERTICAL SIDING
  - ③ - FIBER CEMENT HORIZONTAL SIDING
  - ④ - PERFORATED MESH METAL RAILINGS
  - ⑤ - WOOD WINDOW TRIM @ SIDING
  - ⑥ - ARCHITECTURAL QUALITY COMPOSITION SHINGLE ROOFING

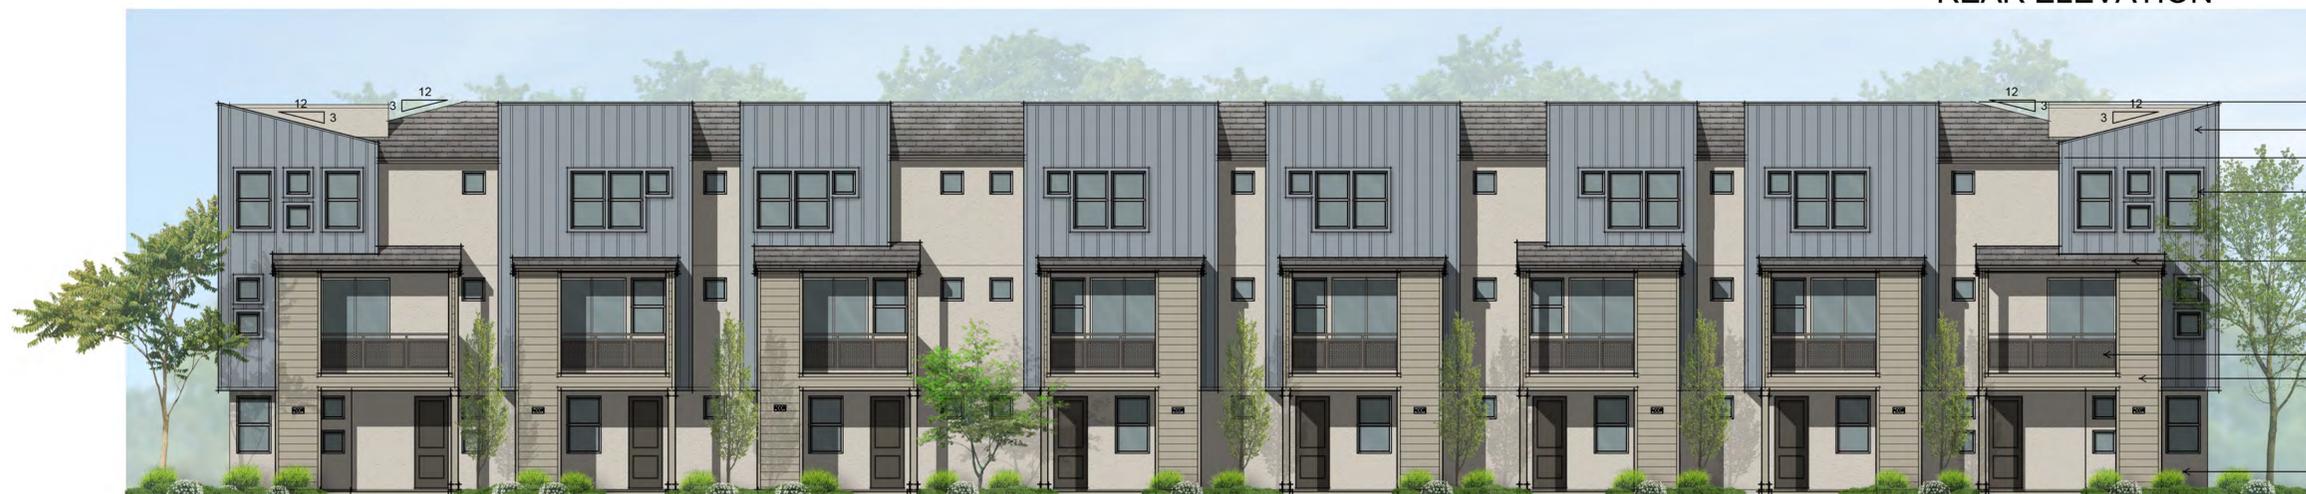
FRONT ELEVATION

- RIDGE HT. 34'-4"
- EAVE HT. 29'-5 1/2"
- ⑤
- ⑥
- ④
- ③
- ①

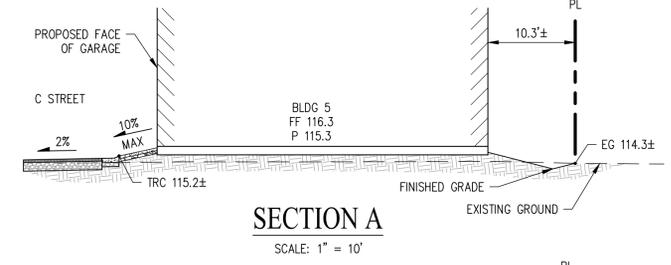
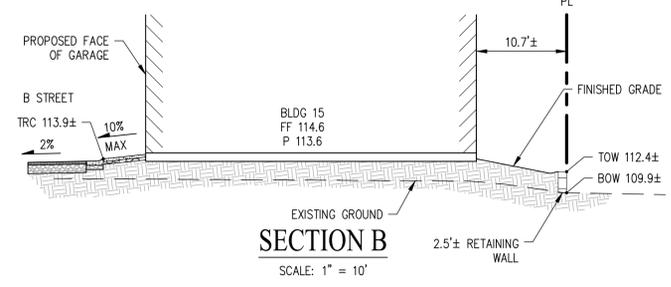
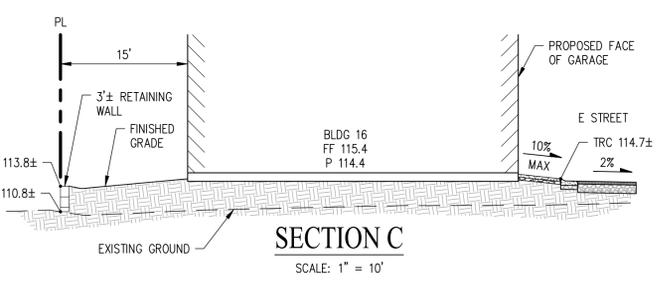
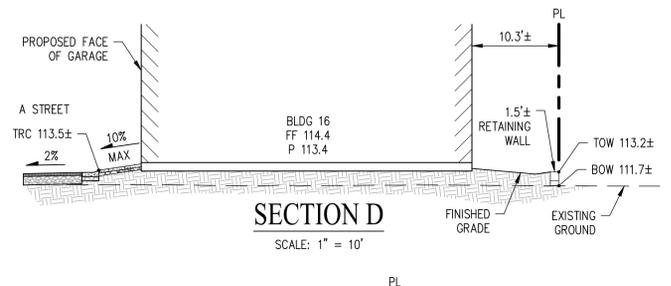
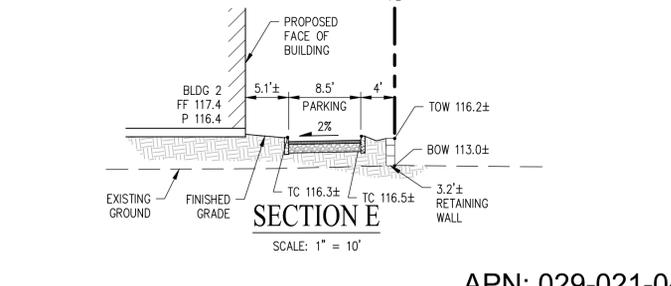
APN: 029-021-047  
**PRELIMINARY GRADING PLAN**  
TM-4

EARTHWORK SUMMARY			
DESCRIPTION	CUT (CY)	FILL (CY)	NET (CY)
ROUGH GRADING	1,700	8,600	6,900 (F)
SUBTOTAL (ROUGH GRADE)	1,700	8,600	6,900 (F)
<b>EARTHWORK SPOILS</b>			
UTILITY SPOILS	4,400	0	4,400 (C)
FOUNDATION AND GARAGE SPOILS	1,900	0	1,900 (C)
<b>TOTAL</b>	<b>8,000</b>	<b>8,600</b>	<b>600 (F)</b>

- EARTHWORK SUMMARY NOTES:**
- UTILITY TRENCHING EXCAVATION VOLUME PER SANTA CRUZ COUNTY DETAIL SS-2.
  - ASSUMED PERIMETER BUILDING FOUNDATION OF 12"x6" AND 12" GARAGE UNDERCUT.
  - ROUGH GRADING CUT AND FILL FACTORS ASSUMED TO BE 1.0.
  - CONTRACTOR TO VERIFY EARTHWORK QUANTITIES PRIOR TO BEGINNING CONSTRUCTION.
  - GEOTECHNICAL REMEDIAL GRADING IS NOT INCLUDED IN THESE QUANTITIES.

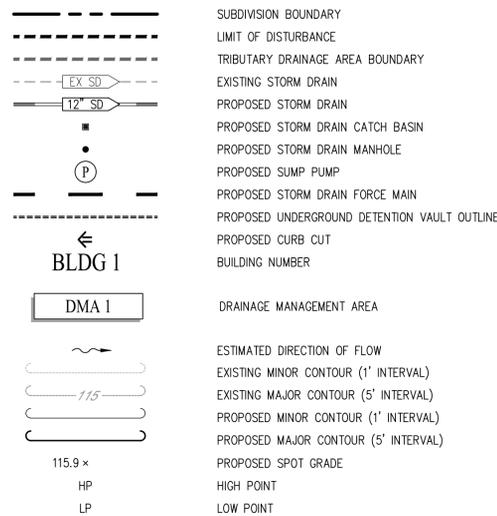
- NOTES:  
 1) EXISTING SOIL CONDITIONS CONSIST OF NEAR-SURFACE INTERBEDDED CLAYS WITH NATIVE TERRACE DEPOSIT SOILS UNDERNEATH AT DEPTHS UP TO 40 FEET. UNDOCUMENTED, MAN-MADE FILL CONSISTING OF LOOSE TO MEDIUM DENSE SANDS, 2 TO 3 FEET THICK BLANKET THE SITE. REFER TO GEOTECHNICAL FEASIBILITY REVIEW BY CORNERSTONE EARTH GROUP, DATED MARCH 29, 2024 FOR FULL DETAILS.

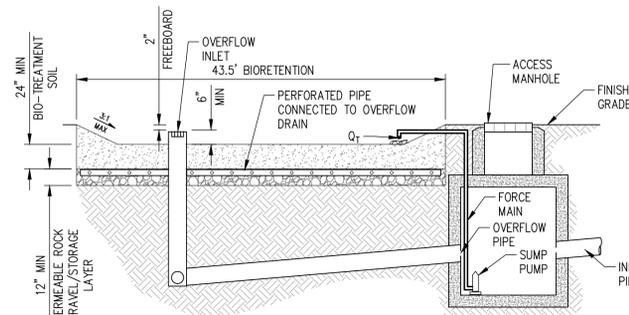
**ONSITE STORMWATER BIOFILTRATION (BF-1)**

- NOTES:  
 (1) PER SANTA CRUZ COUNTY DESIGN CRITERIA, 2024 EDITION.  
 • ANTECEDENT MOISTURE FACTOR (C<sub>a</sub>) = 1.0  
 • RUNOFF COEFFICIENT (C) = 0.75  
 (2-10 YEAR RECURRENCE INTERVAL)  
 (HIGH RESIDENTIAL, MULTIPLE FAMILY DWELLINGS)  
 (2) PER PROVISION C.3 4% RULE.

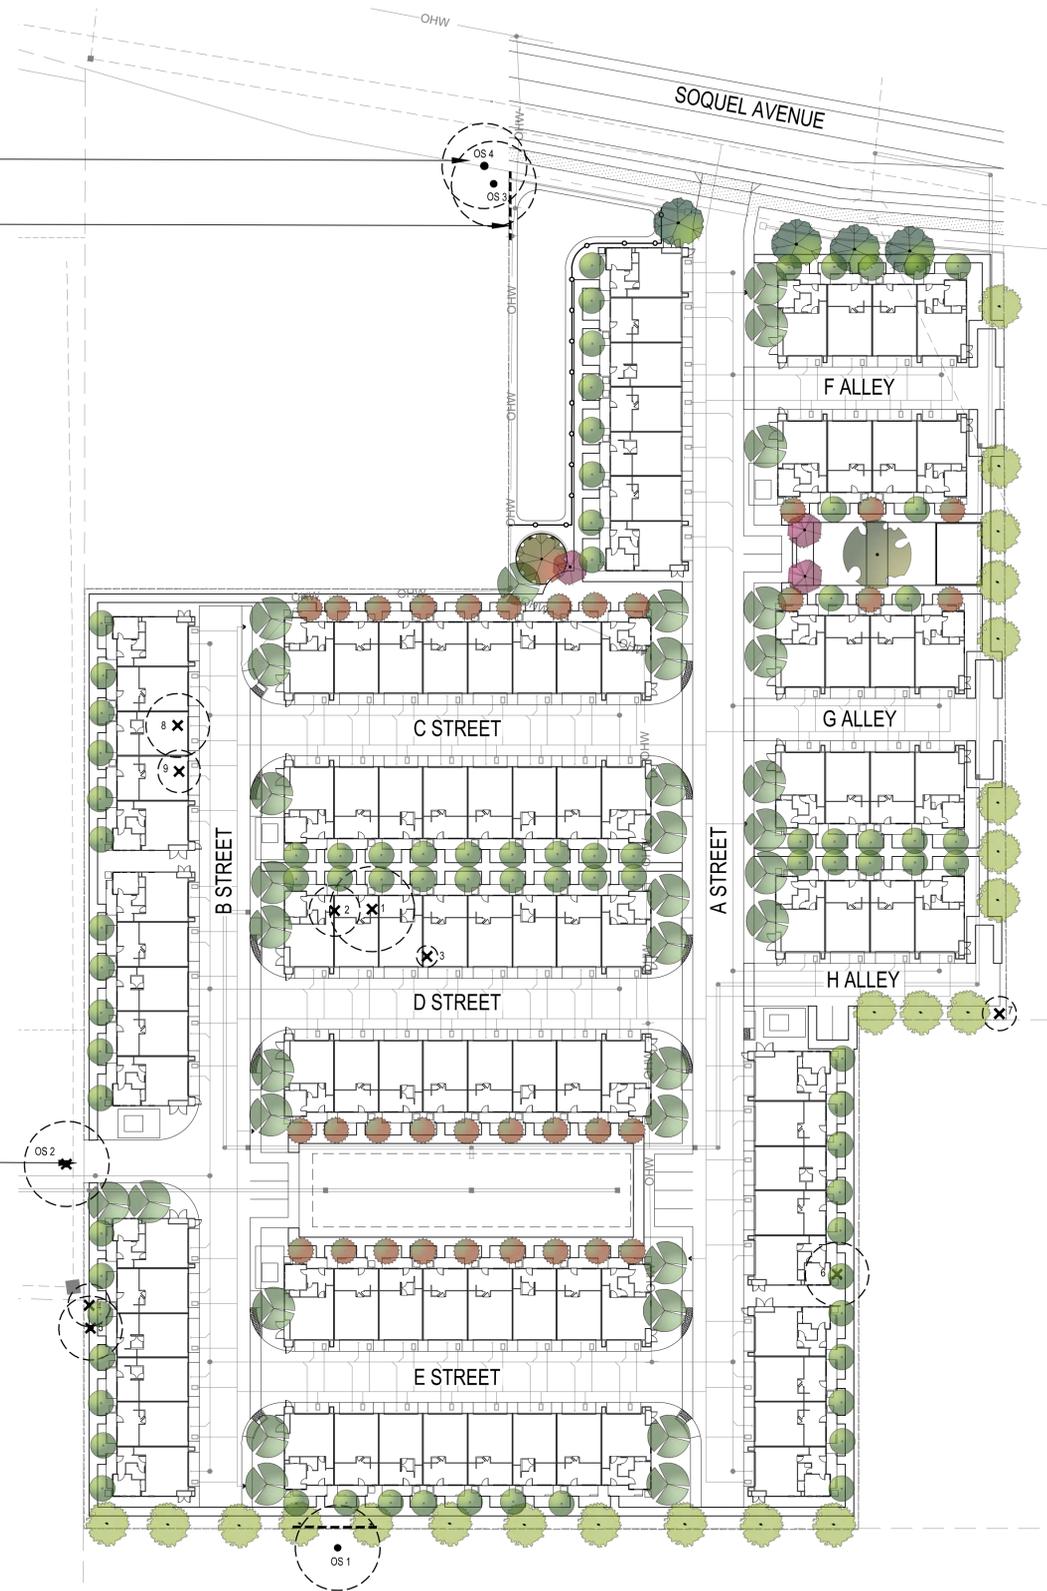
TREE PROTECTION FENCING, TYPICAL. SEE DETAIL A, SHEET L2

TREE TO BE REMOVED PER ADJACENT PROPERTY

ON-SITE TREE MITIGATION TABLE			
TOTAL TREES TO BE REMOVED	QTY	REPLACEMENT RATIO-SIZE	QUANTITY REQUIRED
	9	3:1 - 15 GALLON	27

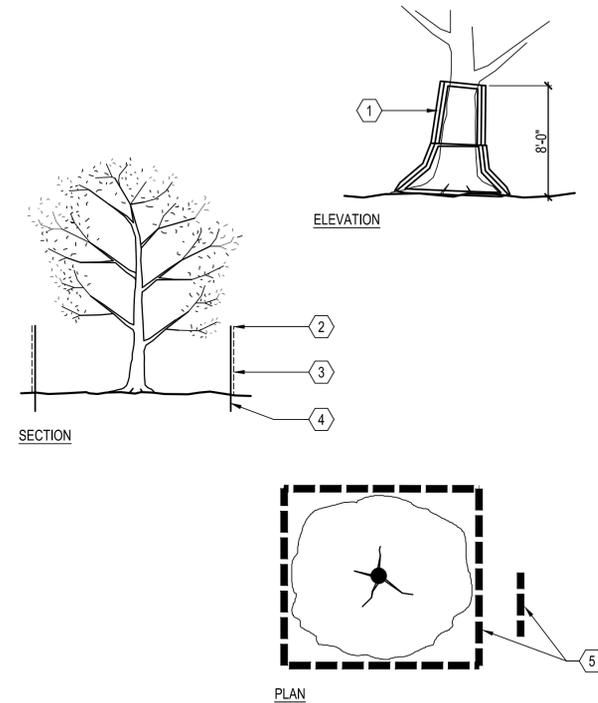
**A TREE PROTECTION FENCING**  
 SCALE: NOT TO SCALE

- NOTES:**
- CONSTRUCTION PERIOD PROTECTION FOR TREES SHOULD BE PROVIDED BEFORE GRADING OR OTHER EQUIPMENT IS ALLOWED ON THE PROPERTY.
  - WHEN CONSTRUCTION IS TO TAKE PLACE BENEATH A TREE CANOPY ON ONE SIDE, THE FENCE SHOULD BE SITED 2 TO 3 FEET BEYOND THAT CONSTRUCTION, BUT BETWEEN CONSTRUCTION AND THE TREE TRUNK.
  - IF CONSTRUCTION OR PAVING IS TO TAKE PLACE THROUGHOUT THE AREA BENEATH CANOPY, AND DRIP LINE FENCING IS NOT PRACTICAL, SNOW FENCING SHOULD BE USED TO PROTECT THE TRUNKS FROM DAMAGE.
- SNOW FENCING THREE LAYERS OF WIRE AND LATH SNOW FENCING TO 8 FEET ABOVE GROUND ON TREES WHERE CONSTRUCTION WILL TAKE PLACE BENEATH THE CANOPY.
  - TOP OF FENCE WITH FLUORESCENT FLAGGING TAPE HUNG EVERY 10 FEET
  - 6" CHAIN LINK OR WELDED WIRE MESH
  - 8" FENCE POST OF 2" DIAMETER GI PIPE OR T-ANGLE POST
  - FENCE PLACED AT DRIP LINE OR 50% GREATER THAN THE TREE CANOPY RADIUS WHERE POSSIBLE

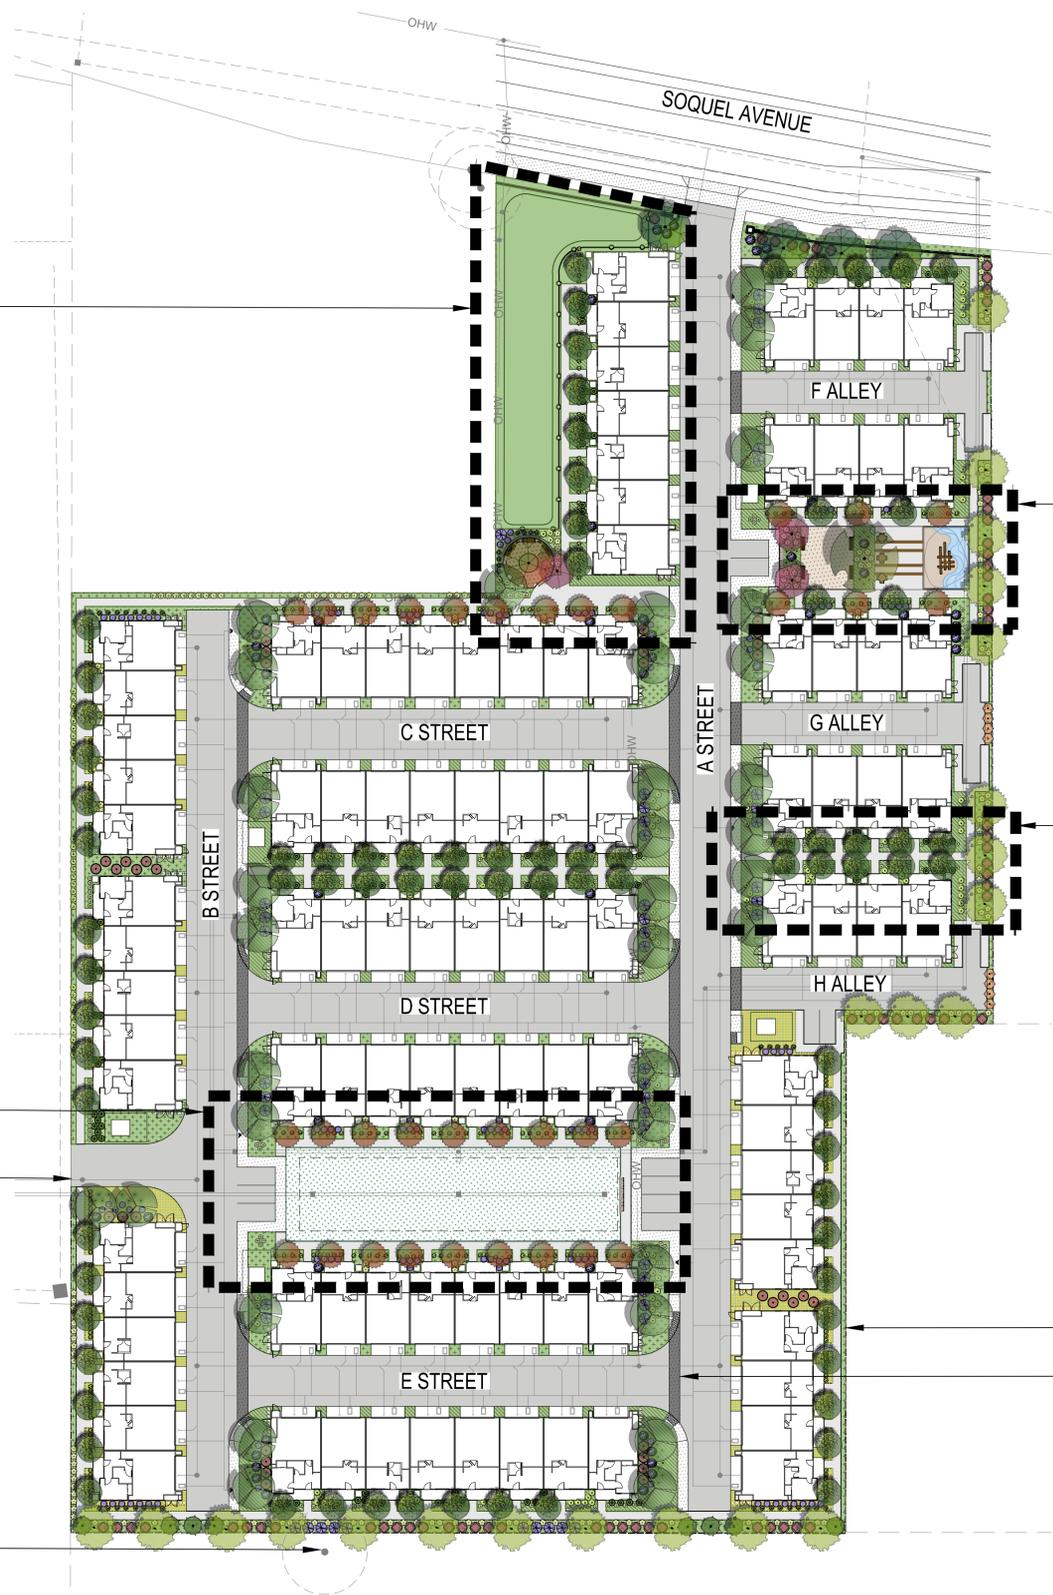
## OVERALL LANDSCAPE PLAN

SEE SHEET L3 FOR OPEN SPACE 1 ENLARGEMENT

SEE SHEET L3 FOR OPEN SPACE 2 ENLARGEMENT
